Rubblising concrete pavement

Project Profile

- ◆ B1441, Weeley Bypass, Essex
- ◆ 300mm thick reinforced, 10.6m wide
- ◆ 5600m² rubblised using the Multi-Head Badger Breaker®
- ◆ Principal Contractor – May Gurney
- ◆ Client – Essex County Council
- ◆ Works commenced 11th October 2004
- ◆ Contract period – 3 weeks

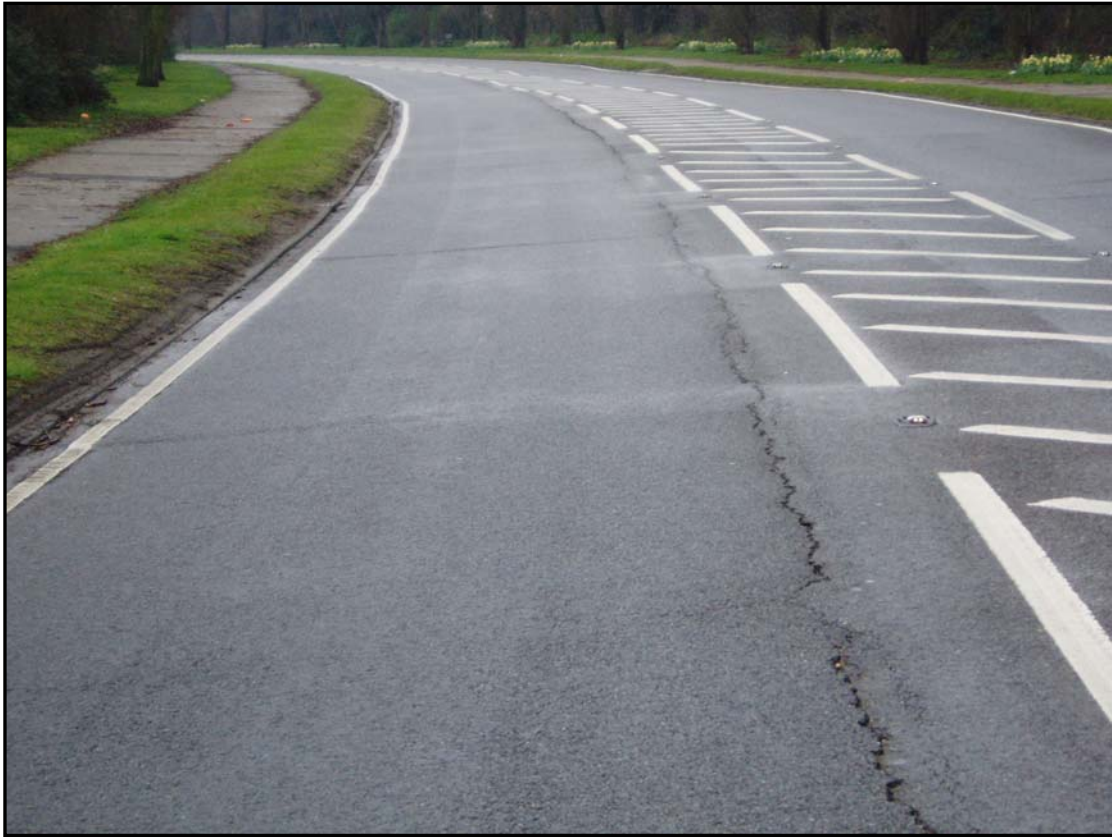
General condition of carriageway before removal of asphalt.
Reflective cracking identifies failure of concrete and subgrade layers

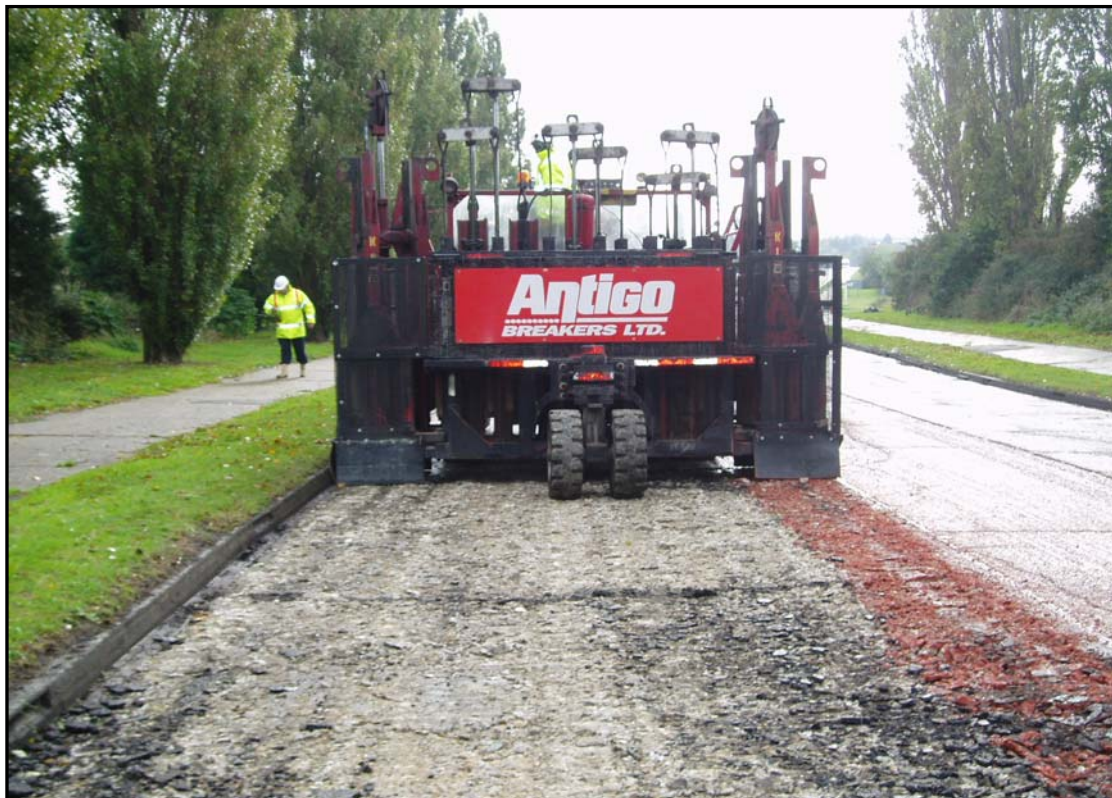
MHB Badger Breaker® rubblizing 1 lane after the removal of asphalt.

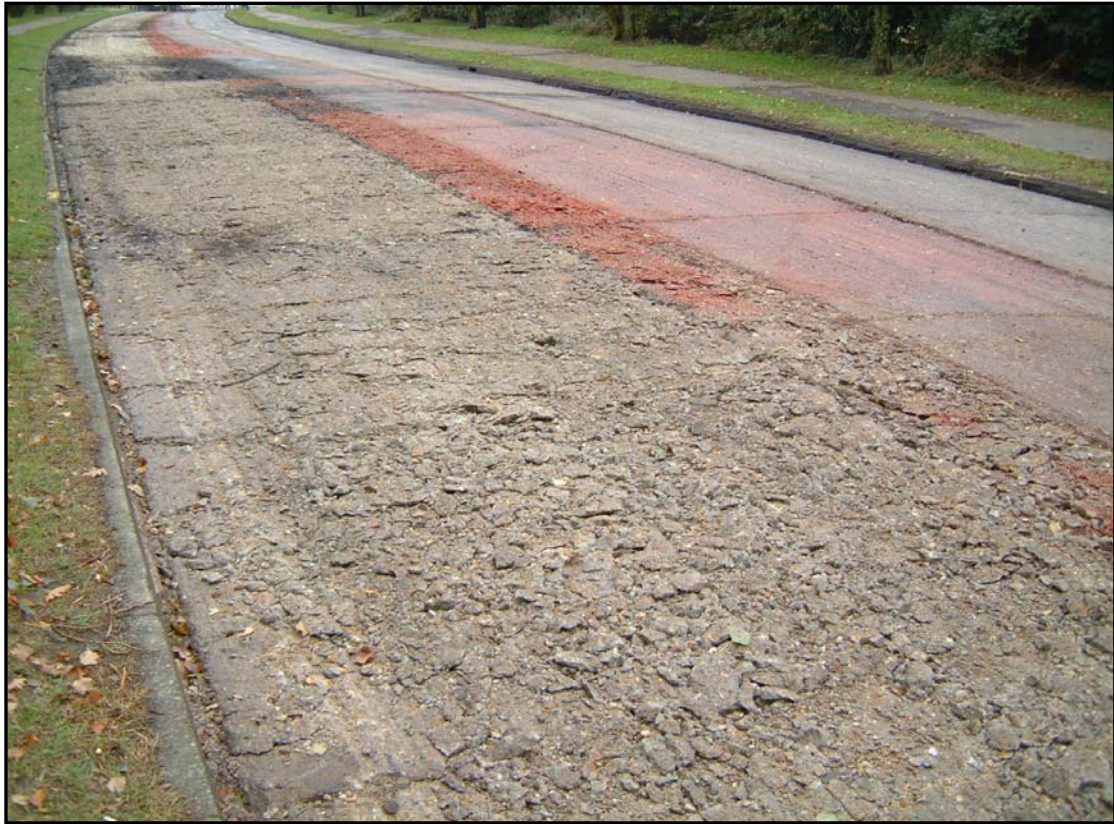
Close up of rubblised pavement

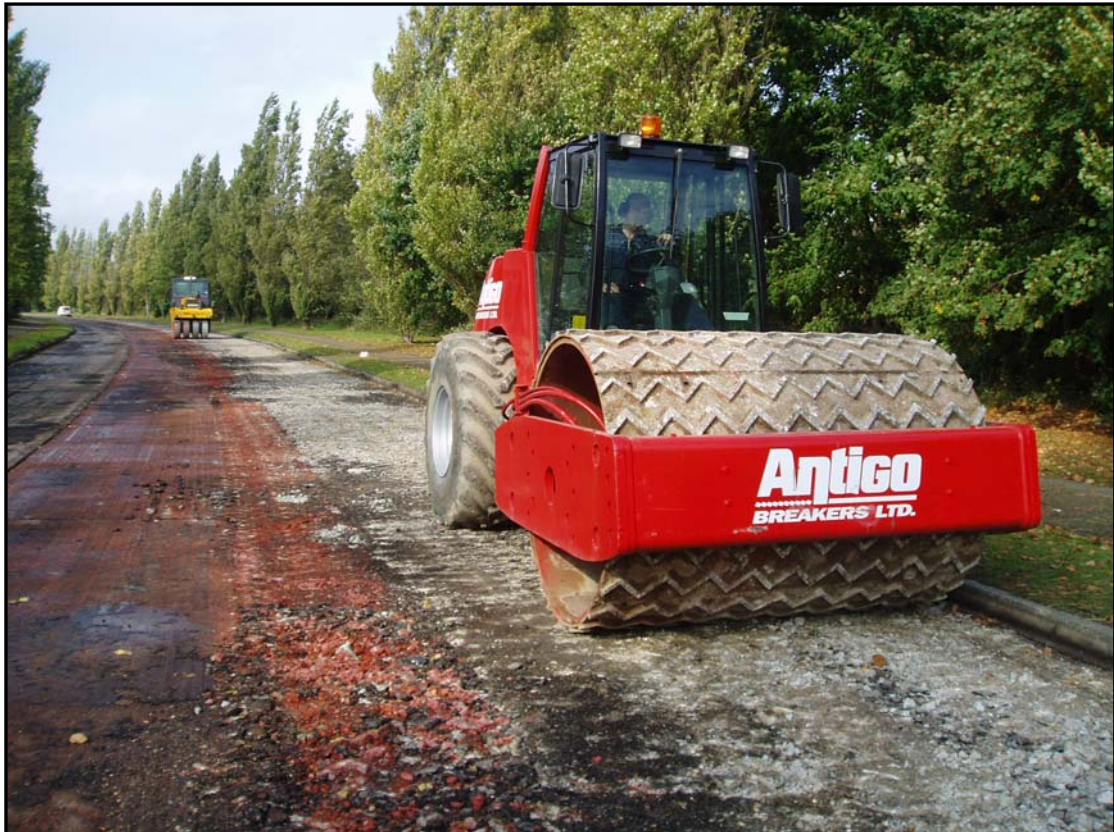
Grid roller reduces surface particle size and compacts rubblised concrete.

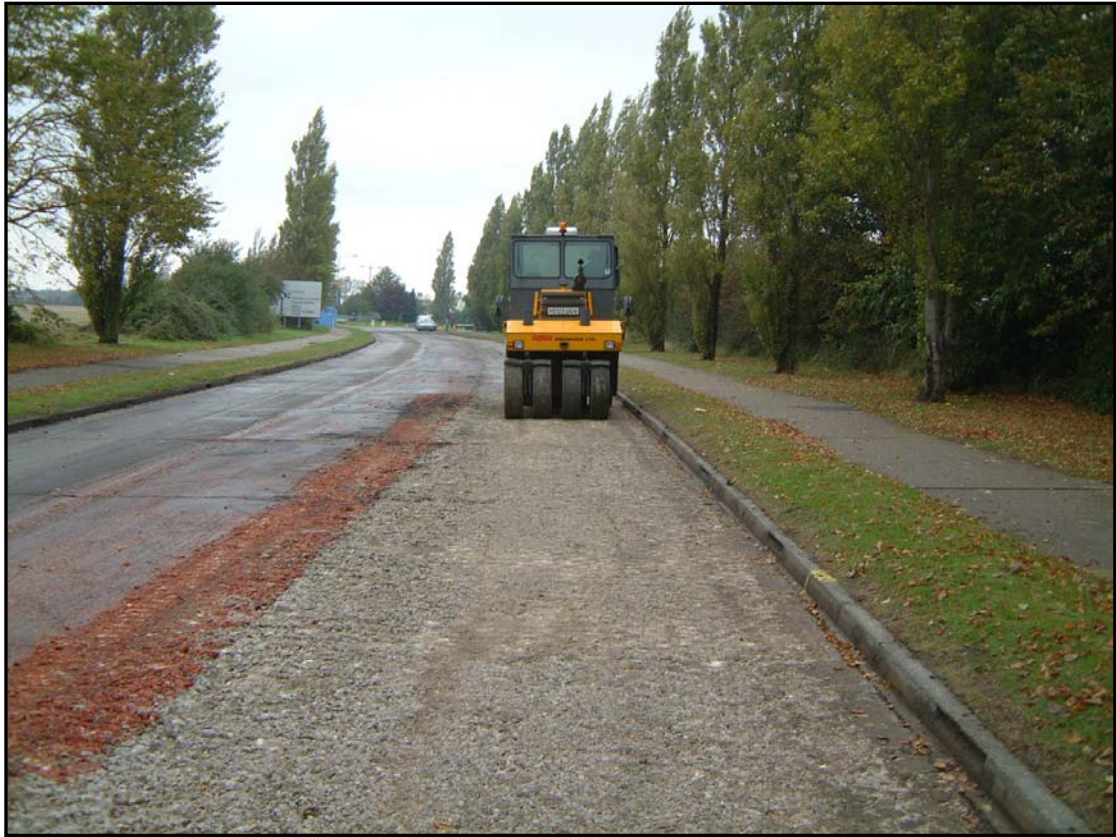
Pneumatic tyre roller completes compaction.

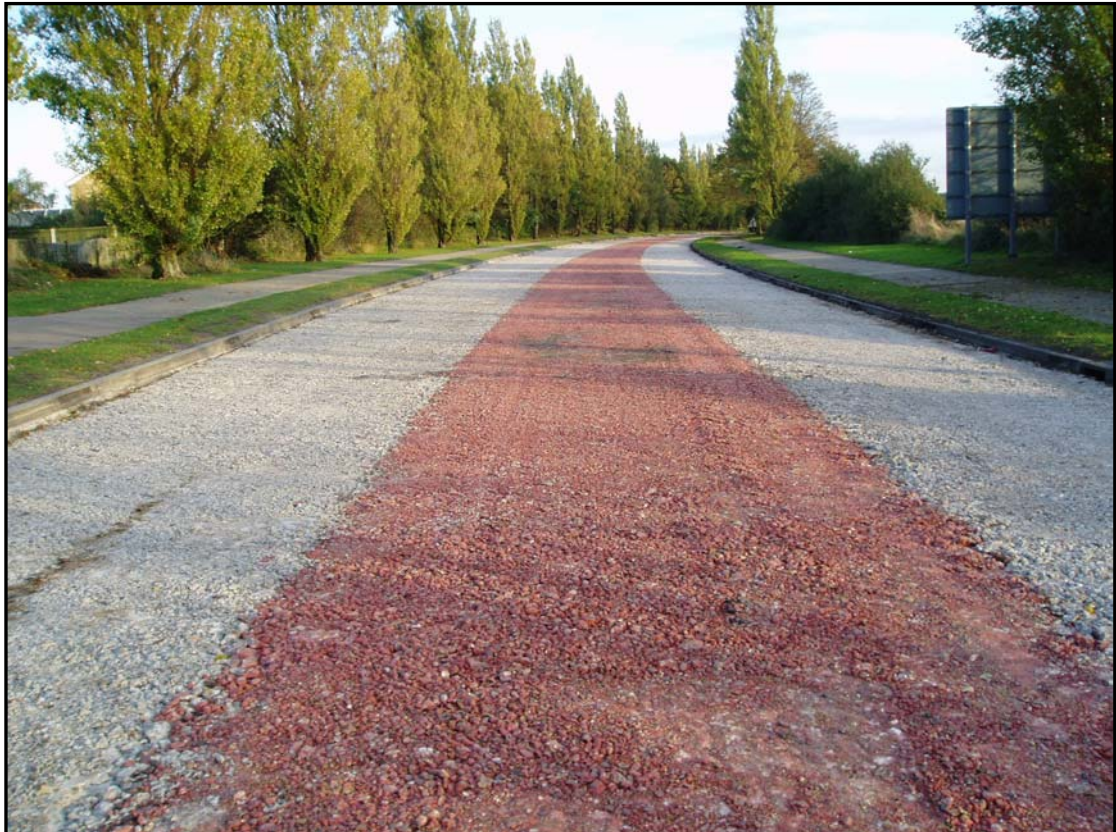
Rubblised concrete surface after compaction – ready for asphalt overlay.

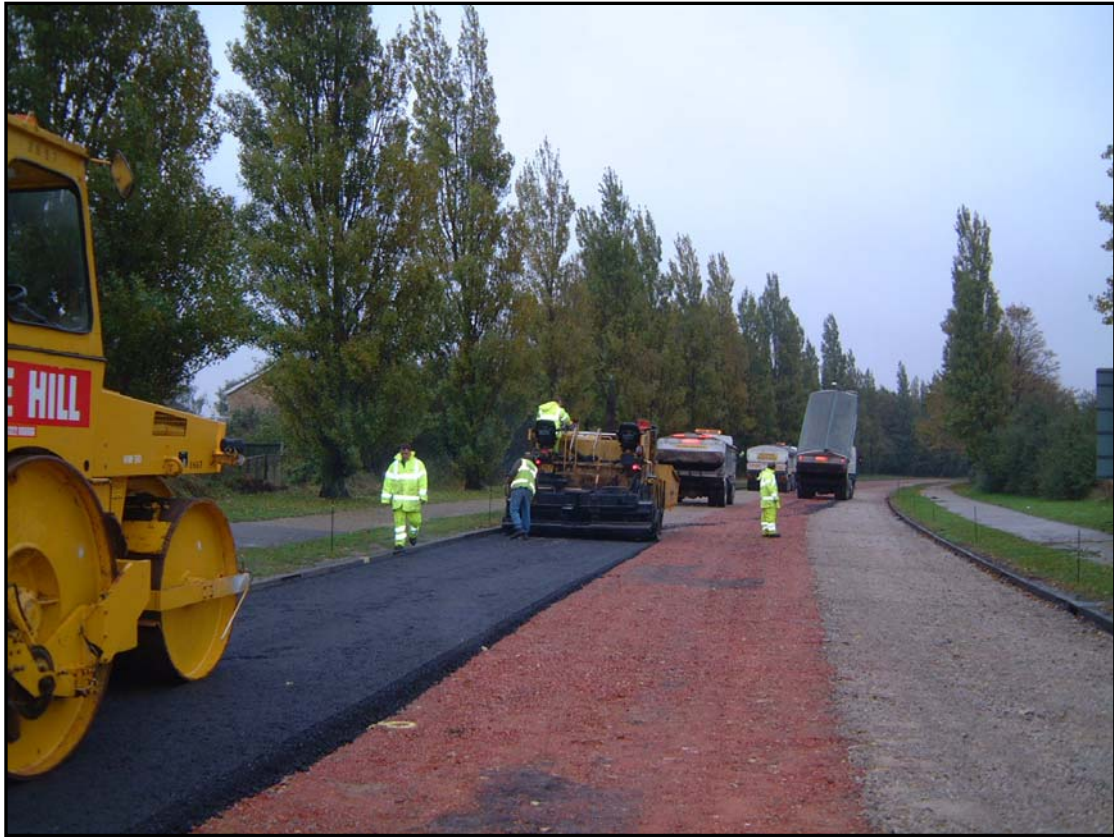
Paving operation on rubblised concrete surface.

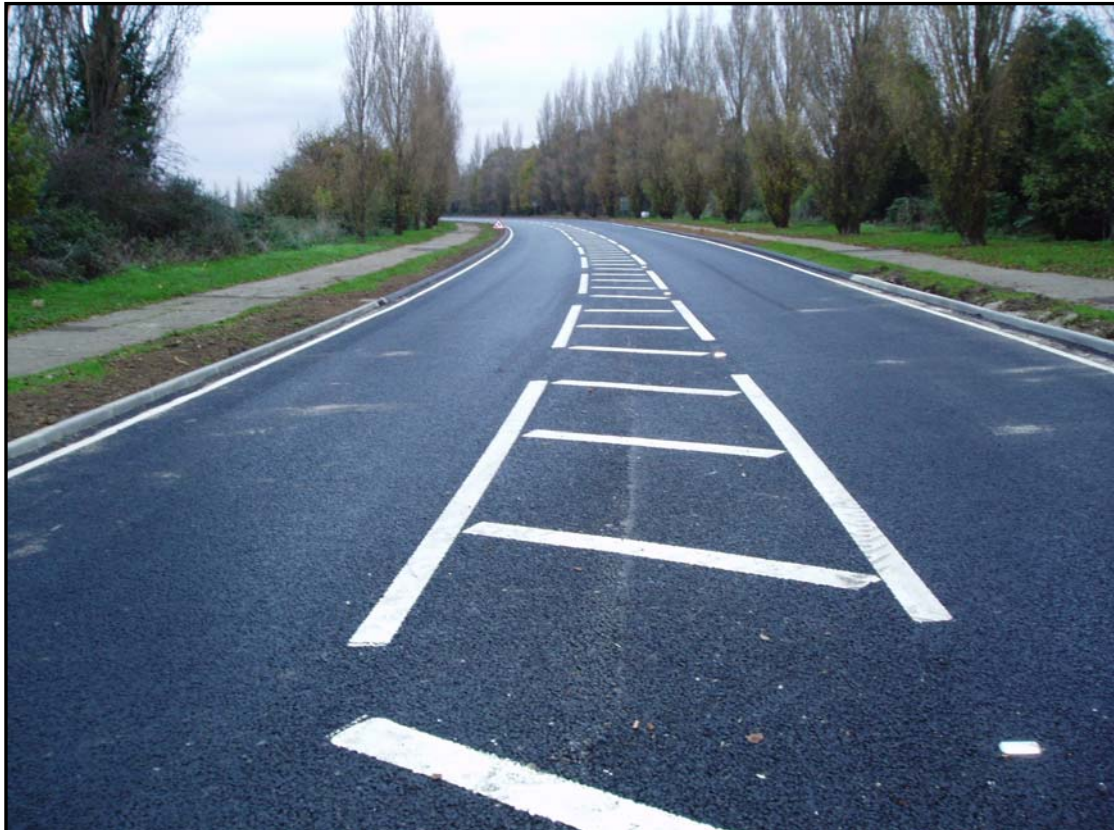
The Weeley Bypass, paved and open to traffic.
